TEST REPORT

Application No.:	BTEK251121001A02S02
Applicant:	Fly Dragon Lighting Equipment. Co., Ltd
Address of Applicant:	NO.4 JINGNENG ROAD 1, HUADU DISTRICT, GUANGZHOU, 510800, CHINA
Manufacturer:	Fly Dragon Lighting Equipment. Co., Ltd
Address of Manufacturer:	NO.4 JINGNENG ROAD 1, HUADU DISTRICT, GUANGZHOU, 510800, CHINA
Factory:	Fly Dragon Lighting Equipment. Co., Ltd
Address of Factory:	NO.4 JINGNENG ROAD 1, HUADU DISTRICT, GUANGZHOU, 510800, CHINA
Equipment Under Test (EUT):	
EUT Name:	Stage Lighting
Model No.:	AURORA AQUA, IP550 BSW
Trade Mark:	LiGHT SKY
Standard(s) :	IEC 60529: 1989 + A1: 1999 + A2: 2013
Date of Receipt:	Nov. 21, 2025
Date of Test:	Nov. 21, 2025 to Dec. 17, 2025
Date of Issue:	Dec. 17, 2025
Test Result:	**Pass***

TEST REPORT
IEC 60529
Degrees of protection provided by enclosures(IP code)

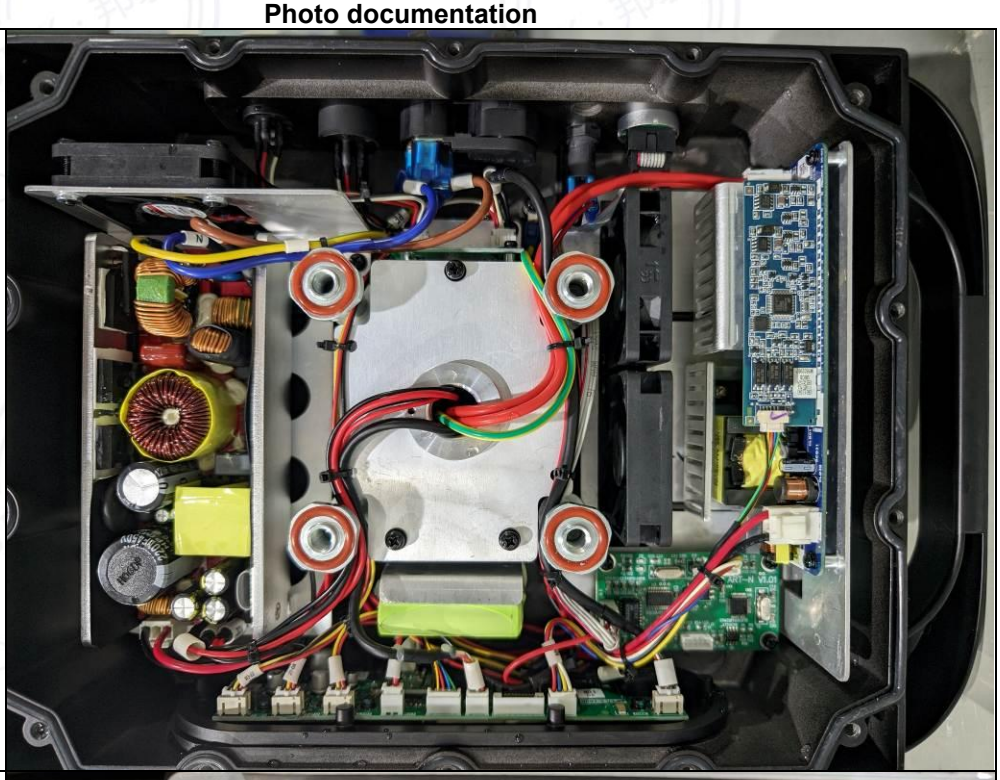
14.3	After testing in accordance with the appropriate requirements of 14.2.1 to 14.2.8 the enclosure shall be inspected for ingress of water	No ingress of water	P
	It is the responsibility of the relevant technical committee to specify the amount of water which may be allowed to enter the enclosure and the details of a dielectric strength test		N/A
	In general, if any water has entered, it shall not:	No ingress of water	N/A
	–be sufficient to interfere with the correct operation of the equipment or impair safety		N/A
	–deposit on insulation parts where it could lead to tracking along the creepage distances		N/A
	–reach live parts or windings not designed to operated when wet		N/A
	–accumulate near the cable end or enter the cable if any		N/A
	If the enclosure is provided with drain-holes, it should be proved by inspection that any water which enters does not accumulate and that it drains away without doing any harm to the equipment	No similar design	N/A

Photo 5 View: After test [ ] front [ ] rear [ ] right side [ ] left side [ ] top [ ] bottom [√] internal

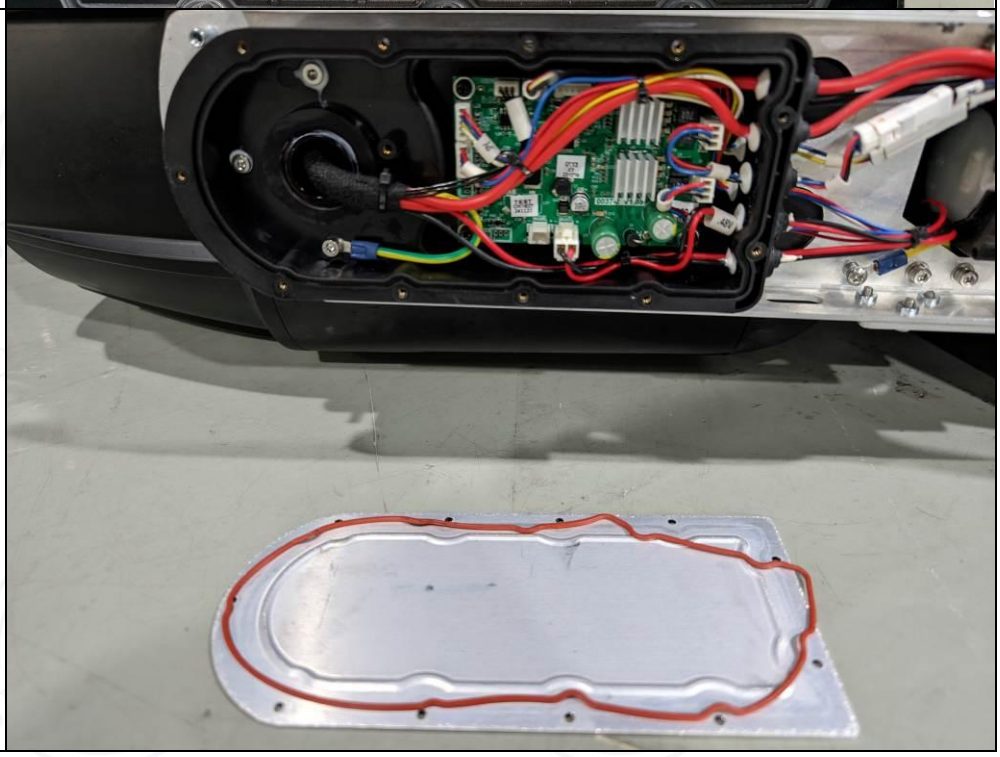
Photo 6 View: After test [ ] front [ ] rear [ ] right side [ ] left side [ ] top [ ] bottom [√] internal
